# ULTRASOUND AND INFRARED COOPERATE to Find Transformer Failures

## The Combination of Two Technologies for Electrical Applications with Gerdau Ameristeel

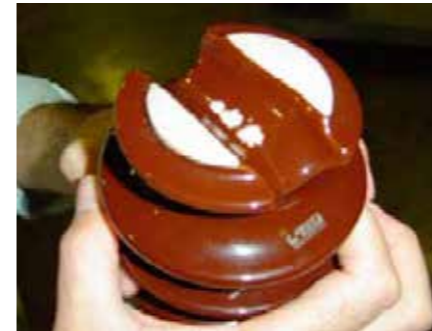
Figure 1 displays an example of an electrical problem detected in its early stages

Figure 1: This insulator was damaged by tracking and eventually arcing. The problem was detected early with ultrasound inspection.

with Ultrasound. The insulator was damaged with tracking which indicates the presence of an equipment fault. When caught at an early stage, it can often be fixed with simple maintenance procedures.

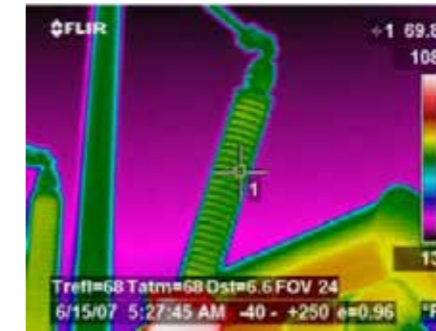
Figure 2: Thermal Images of A-phase bushing on this 161kV to 13.8kV step down transformer showed no apparent hot spots.

Thermal images from several 161kV to 13.8kV step down transformers were provided to us by Young. While using infrared imaging there was no visible hot spots on the A, B and C phase bushings as shown in Figure 2, but an ultrasound measurement taken produced a sound file with obvious indications of early tracking shown in Figure 3.

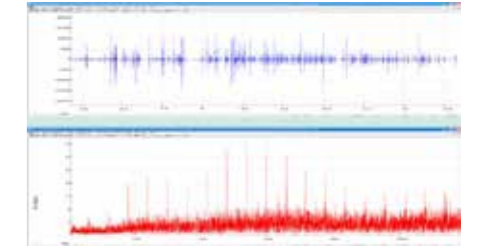
The top image illustrates the time domain showing the build-up and release of the ionization discharge as it finds a path to ground. Ultrasonically, we hear the build-up and then a neutralization of the air surrounding the problem. Heat does not build up here until the situation progresses and there is sufficient flow or current to produce heat along the discharge path.

The bottom image illustrates the spectrum domain from Young’s ultrasonic data. There are two things to note here. First, the obvious repetition of 60 Hz events clearly tells us that, in addition to tracking, there is a presence of nuisance corona. Secondly, the noise level between the 60 Hz peaks confirms there is tracking activity.

Figure 3: The sound file can be viewed in both the time (top image) and spectrum (bottom image) domain. The top shows tracking picked up in the ultrasound range from the A-Phase bushing of the transformer.

Once the diagnosis was made on the suspect transformers, the decision to perform simple maintenance during

the next planned outage was made. Since the problem was discovered at an early stage the simple maintenance could be done on the terms of the maintenance crew rather than dictated by asset failure.

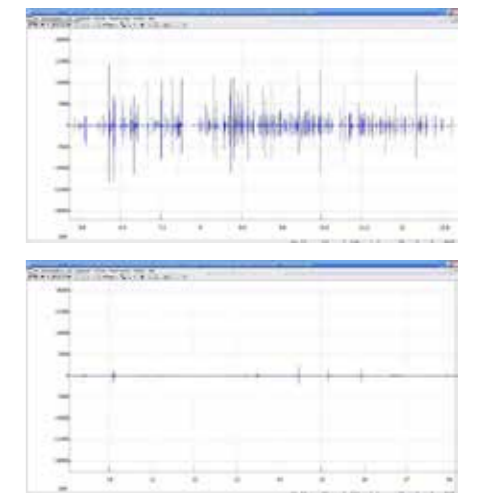
Figure 4: Time signal of ultrasonically detected tracking on A-Phase bushing before (left) and after (right) the simple maintenance of cleaning and tightening of connections.

According to Young, the simple maintenance merely included a cleaning and tightening of all connections on A, B, and C phase bushings. Looking at the time signal in Figure 4 and the frequency signal in figure 5, we can see that simple maintenance definitely improved the condition of the electrical assets. Since tracking is a stage of partial discharge that causes damage to connectors and insulators, it will be necessary for Young to continue vigilant ultrasound scans on the transformers.

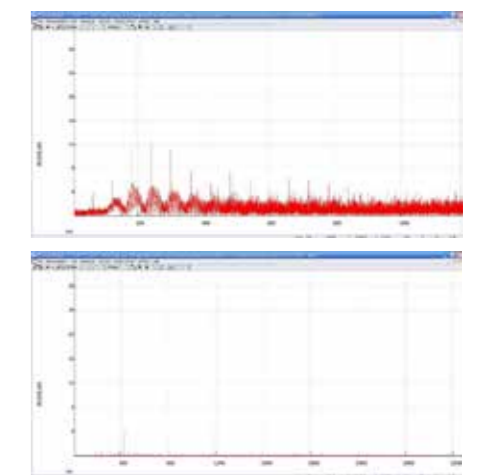
Figure 5: Frequency signal of ultrasonically detected tracking on A-Phase bushing before (left) and after (right) the simple maintenance of cleaning and tightening of connections. Dominant 60hz peaks are gone, as is the tracking noise between peaks.
