JANUARY/FEBRUARY 2021

TRANSFORMER TECHNOLOGY^{MAG}

Twin Technologies Test Transformer Reliability

by Allan Rienstra

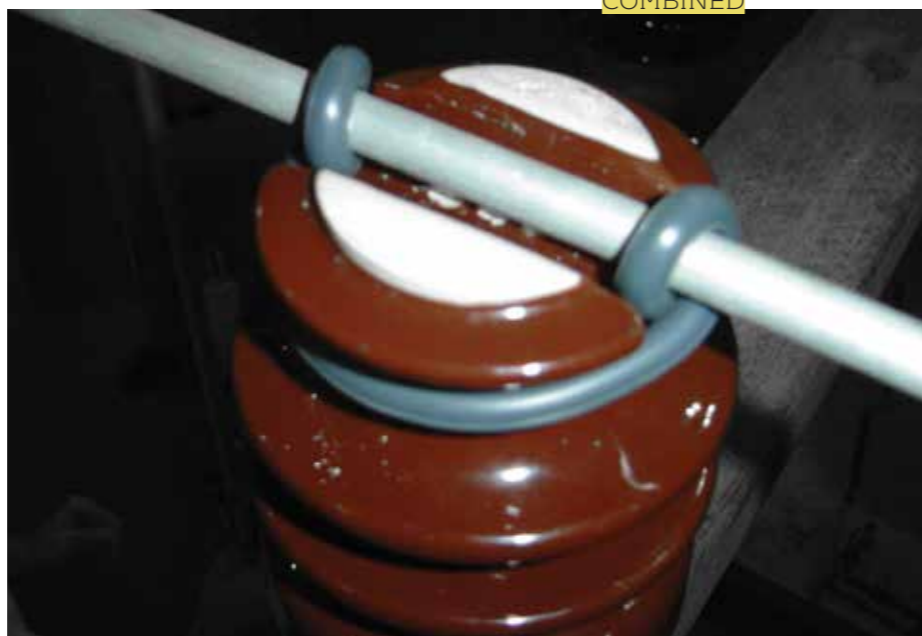
Figure 2. Tracking has begun to erode the enamel coating on this insulator. Moisture can impregnate and either super heat (arcing) or freeze. The insulative properties are failing and partial discharge will only worsen from here.

Figure 2 displays an example of an electrical problem detected in its early stages with ultrasound. The insulator was damaged with tracking which indicates the presence of an equipment fault. When caught at an early stage, it can often be fixed with simple maintenance procedures.

The earlier an electrical fault is detected the less expensive it is to schedule and perform maintenance to mitigate risks. Early detection of an electrical fault can be the difference between a simple dusting and cleaning versus costly overhaul or even total repair/replacement.

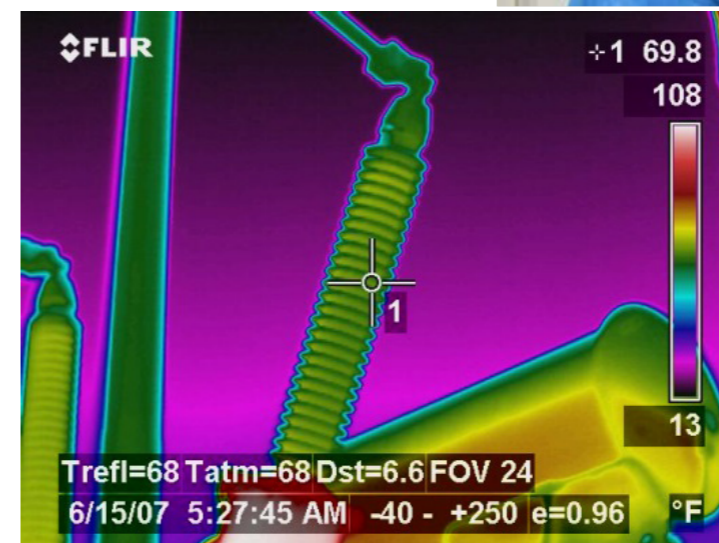
Thermal images from several 161 kV to 13.8 kV step-down transformers were included in Young's report. The infrared image reveals no hot spots on the A phase bushings (Figure 3), but an ultrasound scan produced a sound file with obvious indications of early tracking.

Figure 3. Infrared did not discover any electrical anomalies; however, additional ultrasound scans revealed the onset of early stages of corona discharge.

Similar tracking activity was discovered from the B and C phase bushings, while neither showed any signs of heat when scanned with an infrared camera.

Once the diagnosis was made on the suspect transformers, the decision to perform simple maintenance during the next planned outage was made. Since the problem was discovered at an early stage, the simple maintenance could be done on the terms of the maintenance crew rather than dictated by asset failure. This involved a cleaning and tightening of all connections on A, B, and C phase bushings.

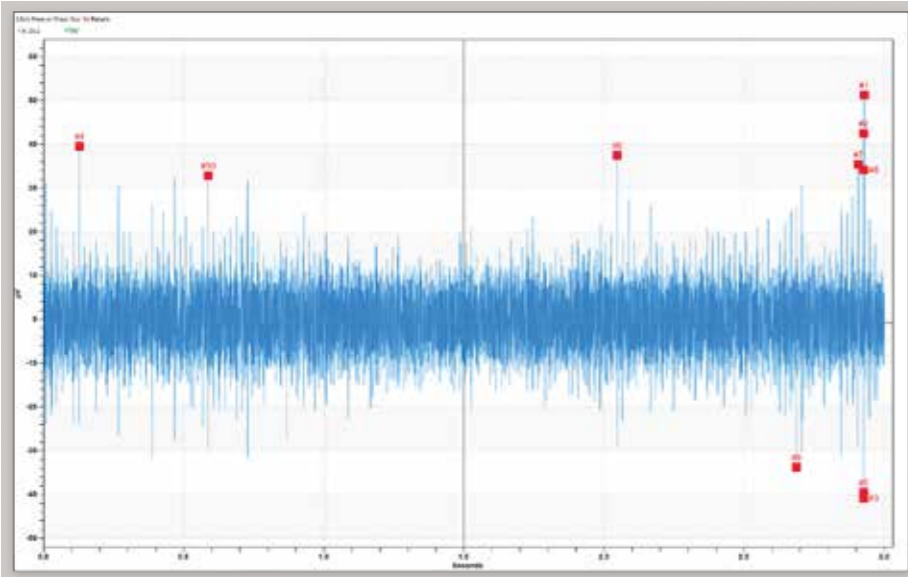
Figure 4. Time waveform taken with SDT270 shows partial discharge activity classified as nuisance corona. Simple maintenance such as cleaning and tightening is required.

Figure 4 illustrates the time domain showing the build-up and release of the ionization discharge as it finds a path to ground. Ultrasonically, we hear the build-up and then a neutralization of the air surrounding the problem. Heat does not build up here until the situation progresses and there is sufficient flow or current to produce heat along the discharge path.

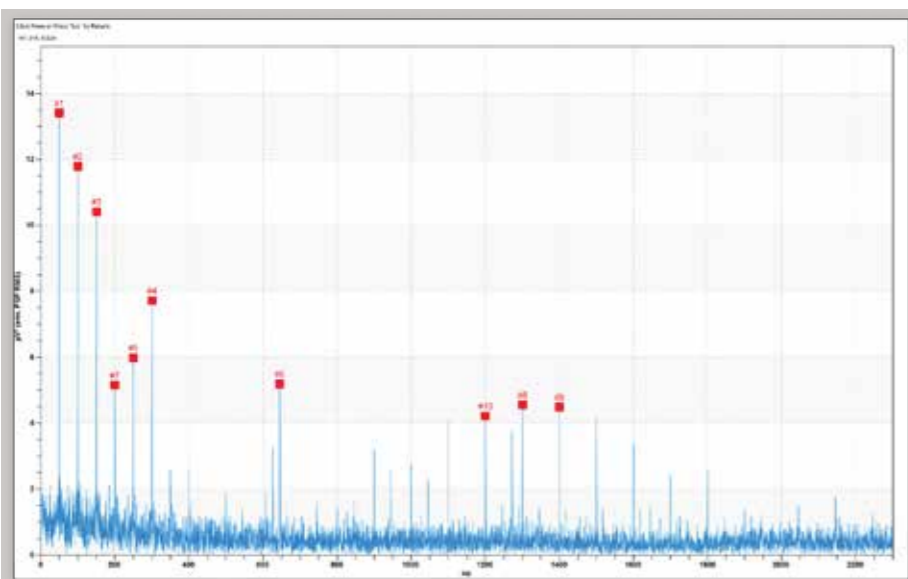
Figure 5 illustrates the spectrum domain from Young's ultrasonic data. There are two things to note

here. First, the repetition of 60 Hz events in the spectrum clearly reveals the presence of nuisance corona at the line frequency. Secondly, the short, abrupt bursts of energy in the timewave image, without the presence of heat, confirms there is tracking activity.

Figure 5. The frequency view of the same ultrasound signal clearly shows 60 Hz line frequency. This is a classic example of nuisance corona.

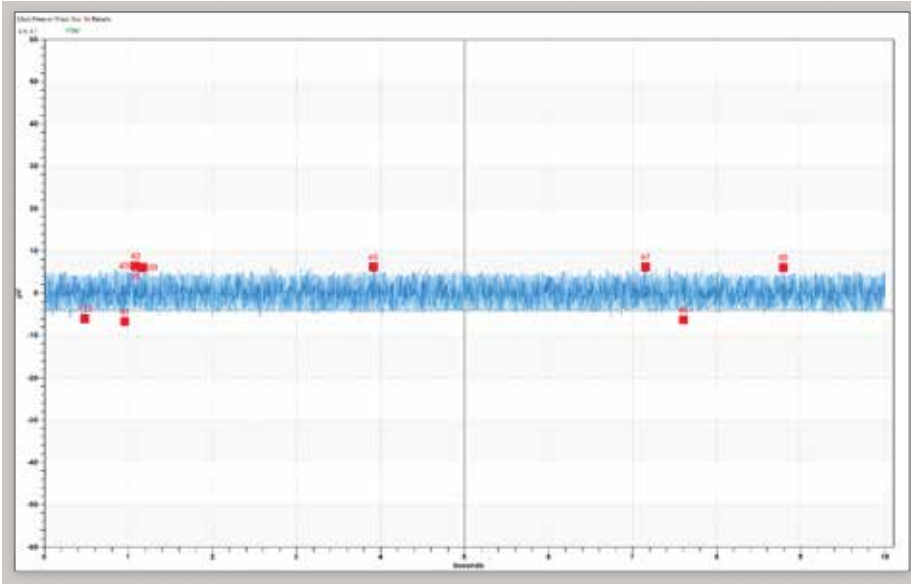
Figure 6. Time waveform after simple maintenance shows a satisfactory drop in discharge activity.

Looking at the time signal in Figure 6 and the frequency signal in Figure 7, maintenance definitely improved the condition of the asset. Since tracking is a stage of partial discharge that does cause damage to connectors and insulators, it will be necessary for Young to continue his vigilant ultrasound scans moving forward.

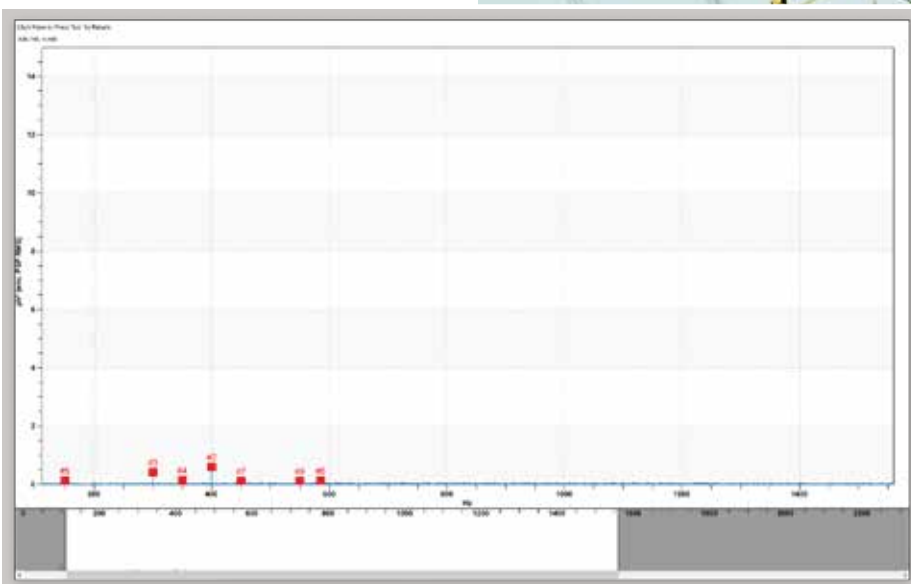
Figure 7. Spectral view after simple maintenance confirms the system was restored to good working condition.
