# Replacing a preventive maintenance practice with predictive technology

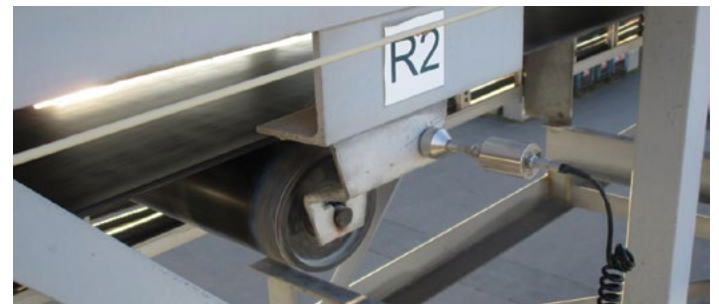
Since our vibration program is important in the plant, I wanted to integrate ultrasound into our existing predictive maintenance practices. That's when we came up with the idea of using it on our CB-1310 conveyor. At first, in 2016, we built a route only at the level of the return rollers. A reading on the roll frame gave us good signal quality for the application.

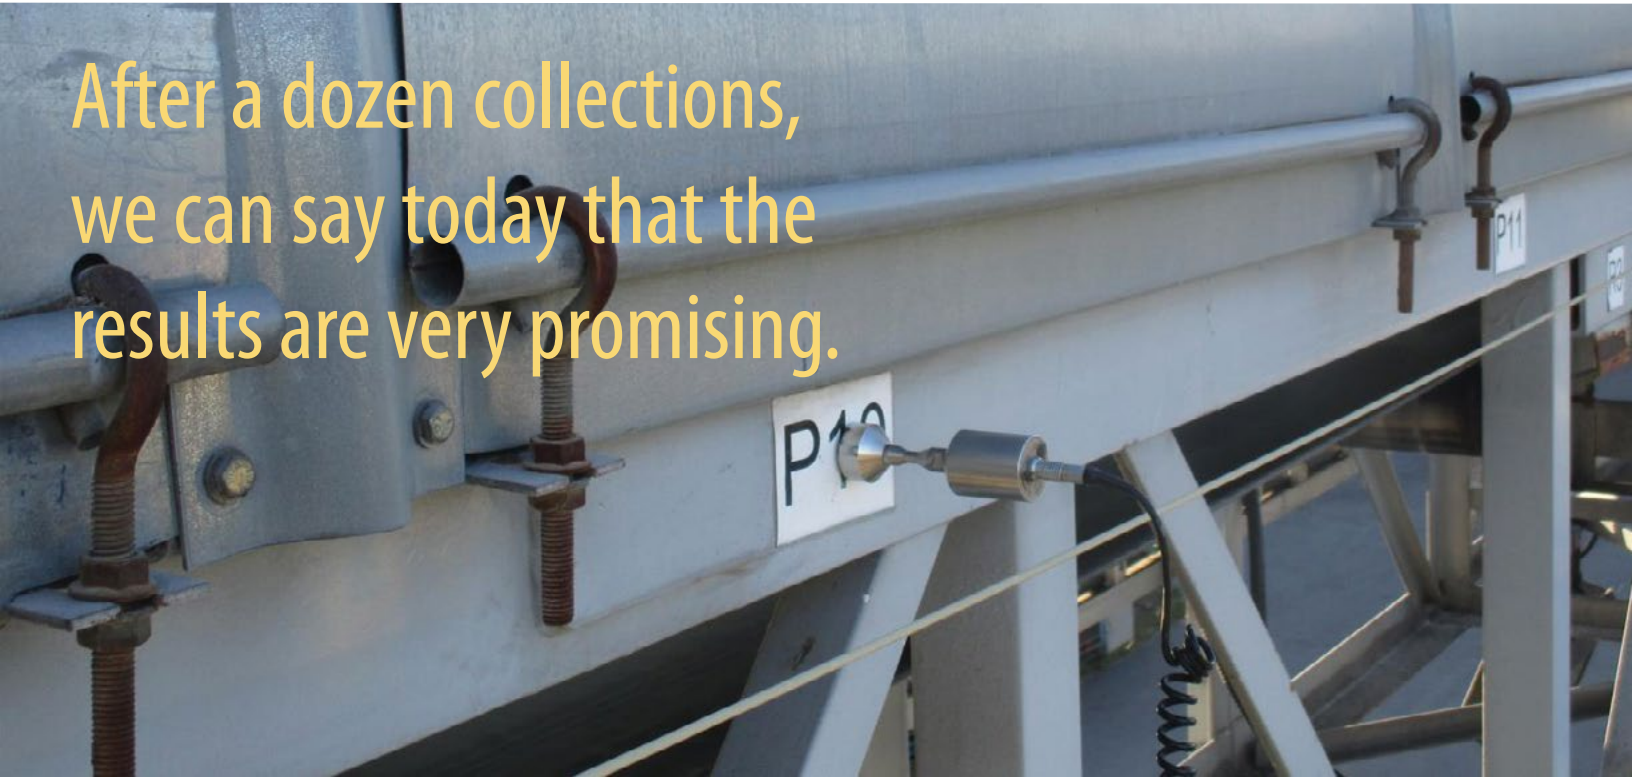
At this time, the previously established preventive maintenance route was still performed. We used these latest inspections to establish a basic level of alarm in dBuV. By comparing the two routes for a few months, we arrived at similar results. Subsequently, we refined our alarms to make sure we could see the problems in advance. Following the satisfactory results obtained, we applied the same method on the carrier rollers without even opening the covers.

We refined our alarms  
to make sure we could see  
the problems in advance.

After a dozen collections,  
we can say today that the  
results are very promising.

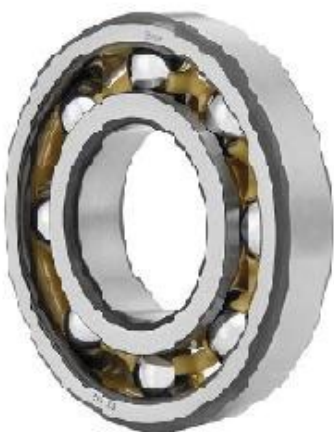
These are the default frequencies for a SKF 6304 bearing:

$f_e$ Rotational frequency of the outer ring	3.97 Hz
$f_c$ Rotational frequency of the rolling element and cage assembly	2.51 Hz
$f_r$ Rotational frequency of a rolling element about its own axis	6.97 Hz
$f_{ip}$ Over-rolling frequency of one point on the inner ring	17.6 Hz
$f_{ep}$ Over-rolling frequency of one point on the outer ring	10.2 Hz
$f_{rp}$ Over-rolling frequency of one point on a rolling element	13.9 Hz

Here are some examples of defects found on our rolls. Unfortunately, for our carrier rollers, I check three rolls at a single reading point and I can not say precisely which one is in fault. These rolls are manufactured with two bearings 6304-2RS / C3 and it is the outer ring of the bearing that rotates at a speed of 238 rpm.
