Detecting Vacuum Leaks in a Multi Effect Evaporator Using Ultrasound Detection

Vacuum Leak Inspection on Multiple Effect Evaporator at major Pacific Northwest pulp & paper mill

Stack, Fourth Effect

Clearwater Pulp, Lewiston, ID

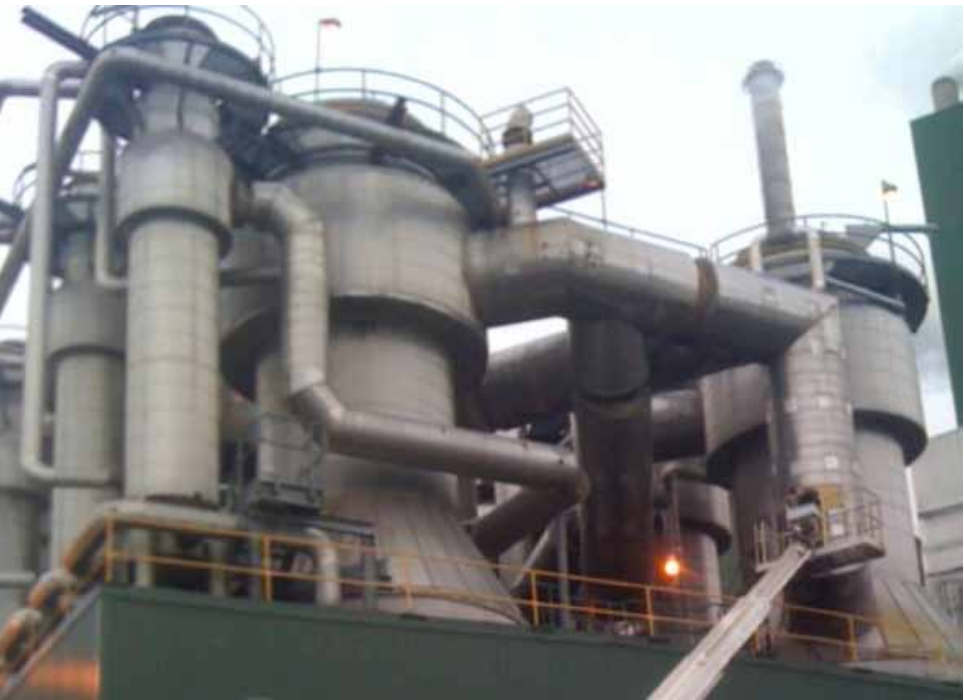
locations along the 4th effect stack. These readings were taken through the insulation and outer steel wrapping. The highest reading noted was 51 db. This location also correlated with the thinnest section of the stack recorded by ultrasonic thickness testing already done by their NDT crew.

Switching to airborne ultrasound detection mode revealed a jump from the ambient levels of 18db to a strong 32dBµV -33 dBµV with the tell-tale whooshing sound of a vacuum leak. When the insulation near the bottom of the access door was moved the airborne ultrasound levels rose to 38dBµV

Diagram shows dB levels mapped out using SDT RS1 Contact Probe. Vacuum leaks detected through 4” insulation and outer sheet steel. Loudest areas were cut away and patched with Gortex patches.

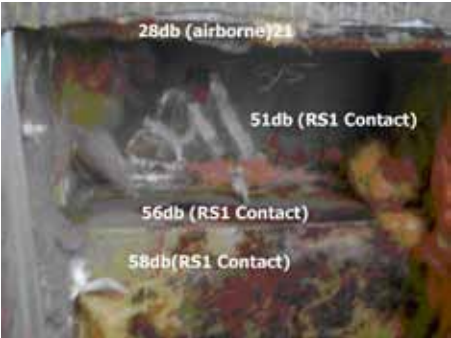
ultrasonic db levels were 18 db around the stack. When I brought the airborne sensor near the 51db access door, the airborne sensor jumped to 32db – 33db and gave the telltale whooshing sound of rapidly moving air. When I used my hand to separate some of the insulation away from the metal flange the airborne sensor levels rose to 38db.

It was decided that we would need to have a larger area opened for inspection. Mr. Storey and I went back to confer with Mr. Frei and Mr. Fleischman (sp?) about how we could gain access to the stack below the retaining ring.

Mr. Storey marked out the approximate dimensions we wanted to have cut away in chalk.

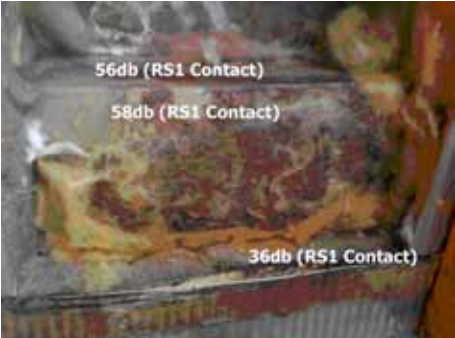
give us better access. Mr. Frei reminded us that we would need to have some type of blocking material to immediately cover the holes we expected to find. If

we did not, the probability of losing the vacuum was great, thus potentially causing the entire process to shutdown.

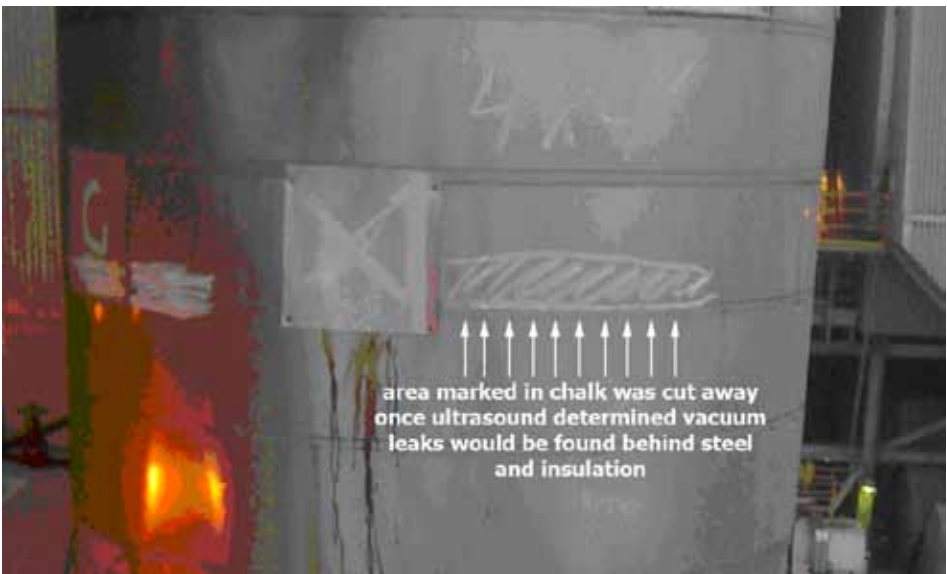
As soon as Mr. Rose removed the sheet steel we could see where the insulation had collapsed around the vacuum pull of the stack. As the insulation was peeled away, the holes were immediately visible. We placed two rubber sheets over the large holes to prevent the loss of vacuum. The sheet on the left covered the largest area of corrosion, about 8” wide. The 2nd major area of damage was about 1½”wide.

along the underside of the metal flange area.

The exact number of holes were too numerous to count. Also many of the holes had blended together from the corrosion.

Mr. Rose recommended applying Gor-Tex™ sheets sealed with silicone to effect a strong, yet temporary repair. The decision was to strengthen and seal the holes so that the process could continue until a planned outage in March 2010. At that time a complete repair/replace-ment could be imple-mented. As they removed more of the sheet metal and insulation for the final repair, additional thickness testing was performed.

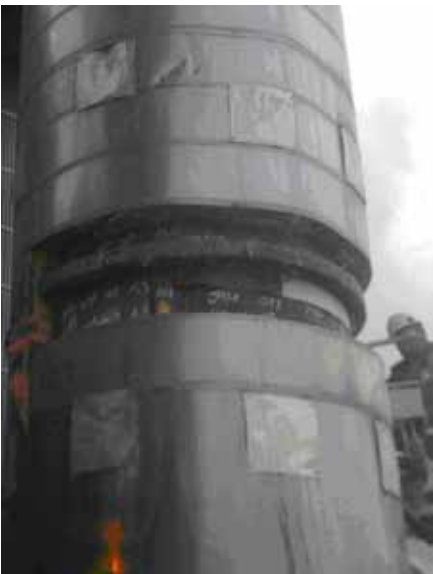
The areas below where the holes were discovered clearly show how the stack is wearing out. 0.077” was the thinnest area found without actually being a hole.

After the Gore-Tex™ sheets were wrapped and sealed, the process monitoring software validated the repair. The amount of vacuum began returning to levels not seen for quite a while. The control valve also moved dramatically into the correct direction right as the
